# CRCP Evaluation and Forensic Studies

Roberto Treviño Flores, P.E.

## 4. Case Study #1 – Austin District

## 5. Case Study #2 – Ft. Worth District

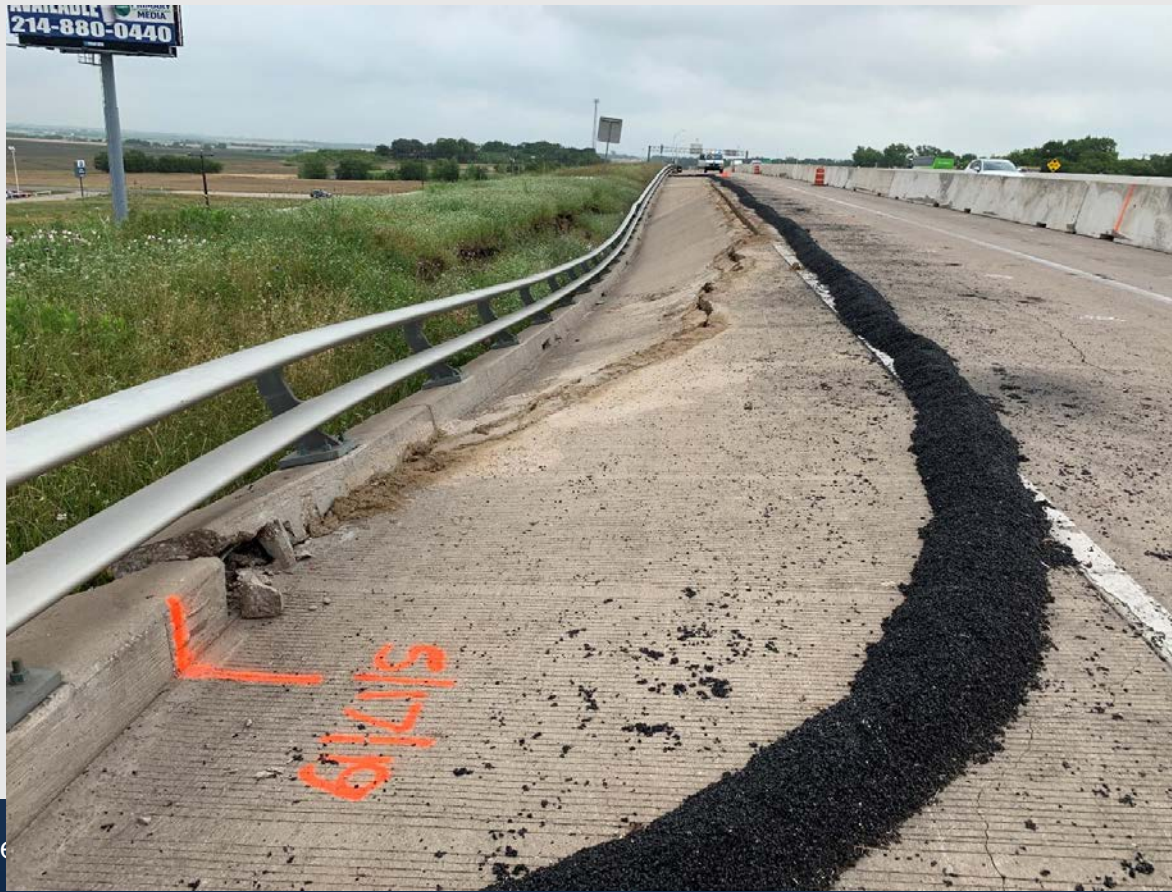
# Forensic Evaluation Process

**Forensic Request  
From TxDOT  
Districts**

**Define the Scope  
and Potential  
Solutions**

**Compile project information  
Develop a field plan  
Conduct site investigation**

**Select a Repair Strategy**

**Evaluate  
Causes of  
Distress**

**Evaluate  
Pavement  
Structural  
Capacity**

**Evaluate Subgrade  
and Base Properties**

**Short-term  
& Long-term  
Monitoring**

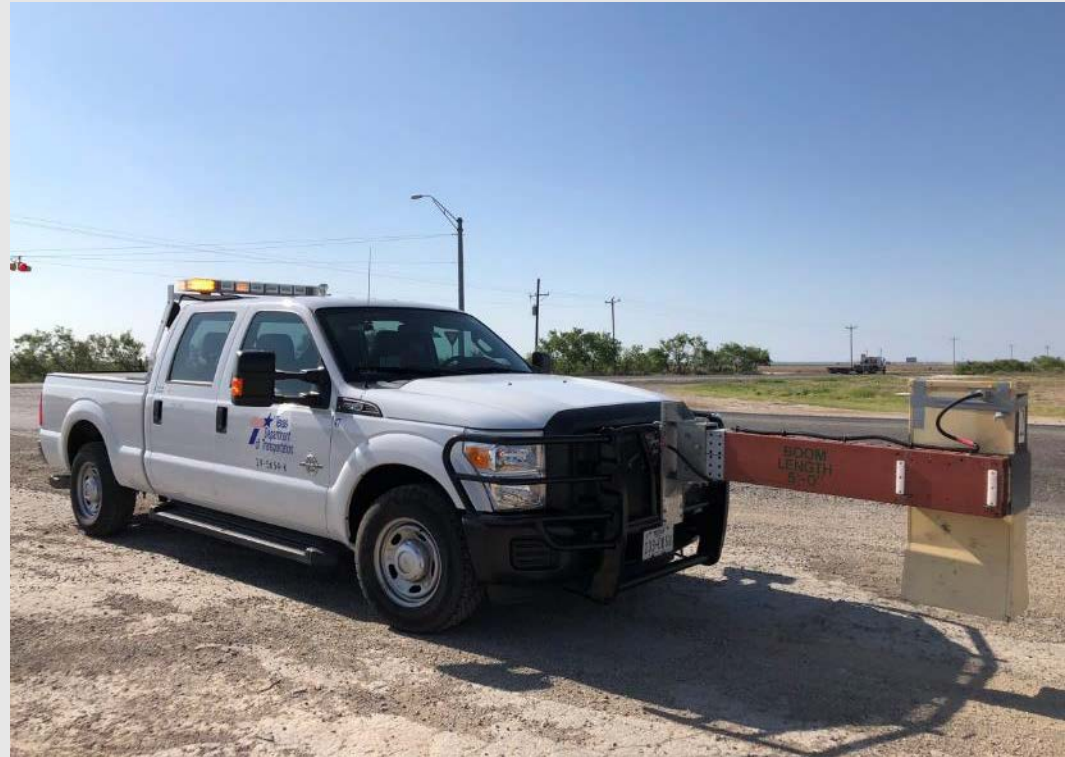
- Frequency: 1 GHz
- Effective depth: ~2 ft.
- Can operate at highway speeds
  - 1 trace every 5 ft. @ 60mph
  - Can collect 1 trace per foot @ 25mph
- Collects Video & GPS

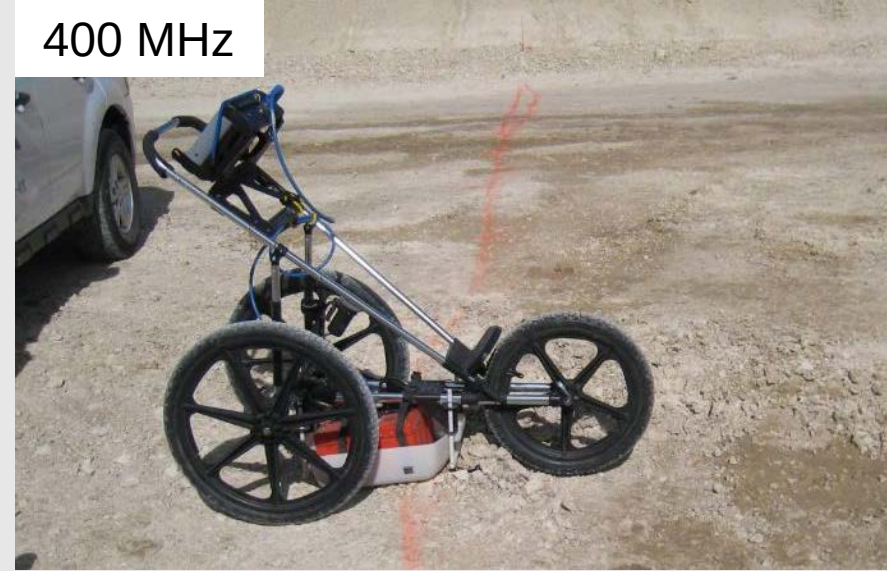
## ❑ Ground Coupled Penetrating Radar

- Antenna in contact w/ surface
- Push cart/handheld/trailer
  - 2.6 GHz ➔ ~1 ft.
  - 400 MHz ➔ ~12 ft.

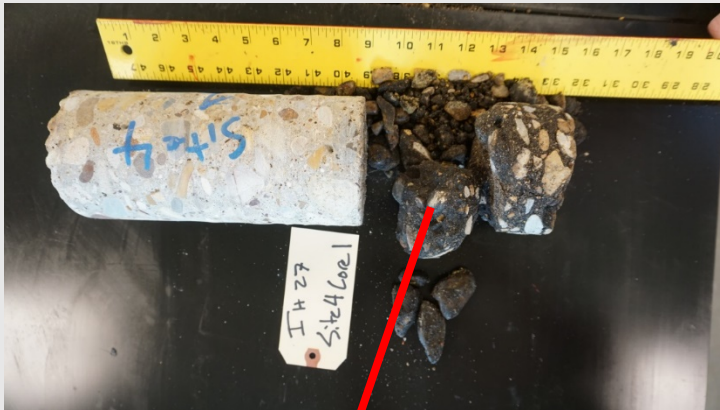
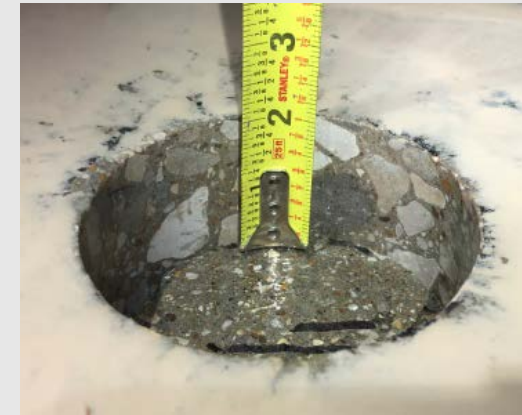
## □ Ground Coupled Penetrating Radar (400 MHz)

- GC-GPR data processing: continue to make progress

Rebar

HMA  
stripping

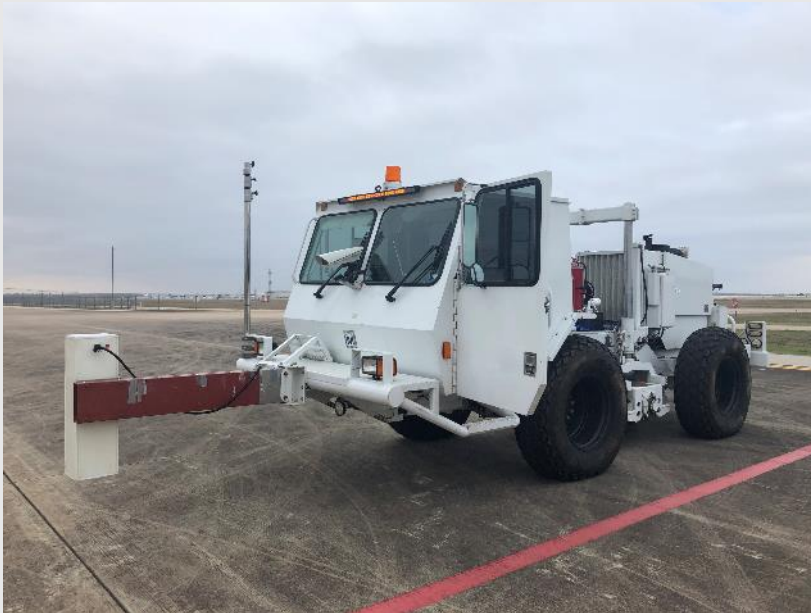
- Collects:
  - Rolling Dynamic Deflectometer (RDD)
  - Video, GPR & GPS
- 2 mph data collection
- 3 geophones
- Deflection recorded every 0.1 ft.

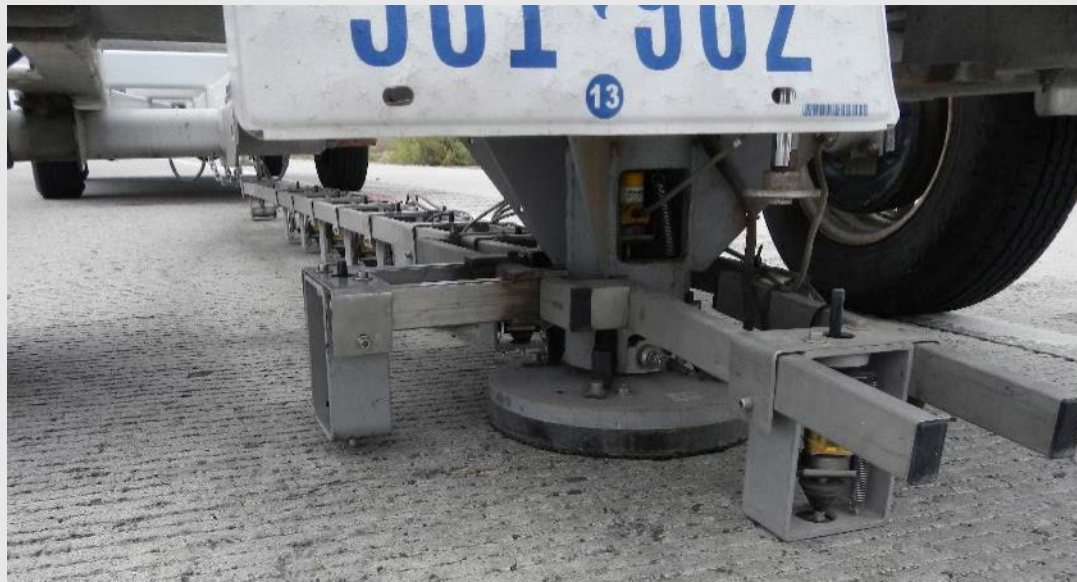
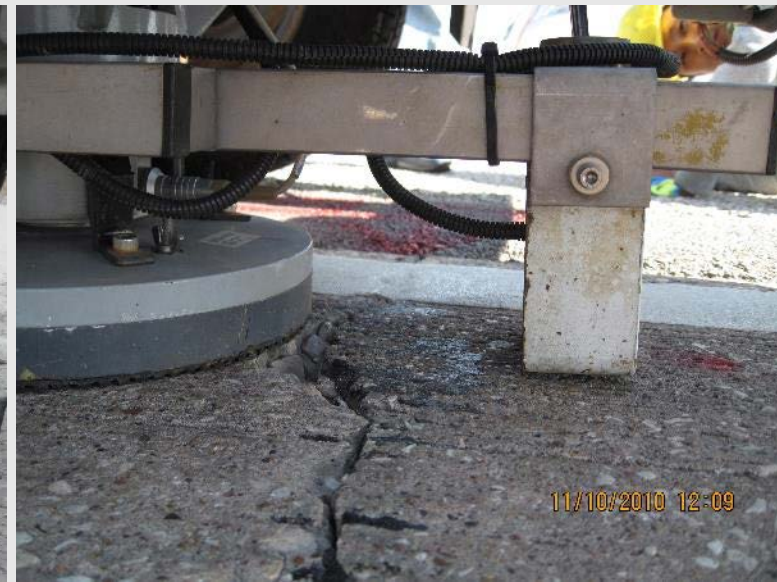
- Drops a load and pavement deflections are measured through 7 to 9 sensors.
- Used to estimate the pavement structural capacity
- Used to evaluate load transfer efficiency at the joints and cracks (rigid)
- Estimation of back-calculated  $k$ -value (rigid)

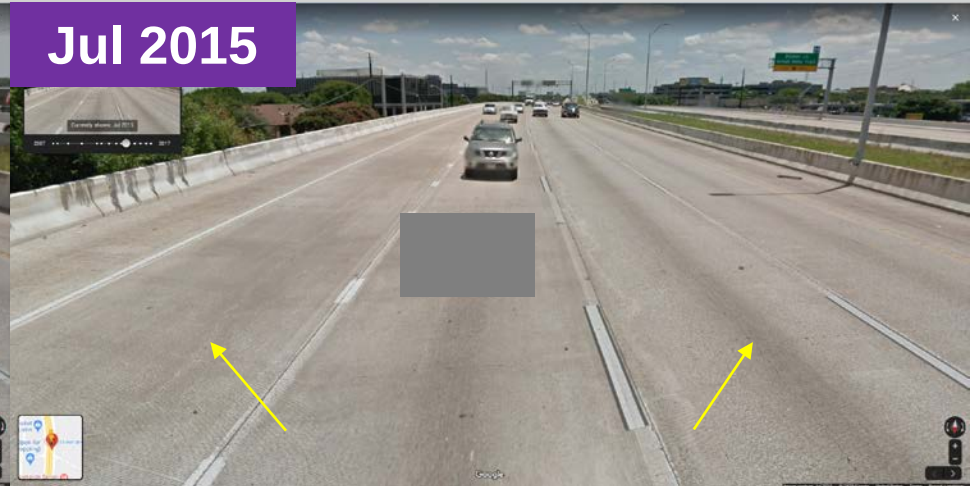
**Jul 2015**

# ❑ No Significant Progress of Longitudinal Crack (2013 to 2019)

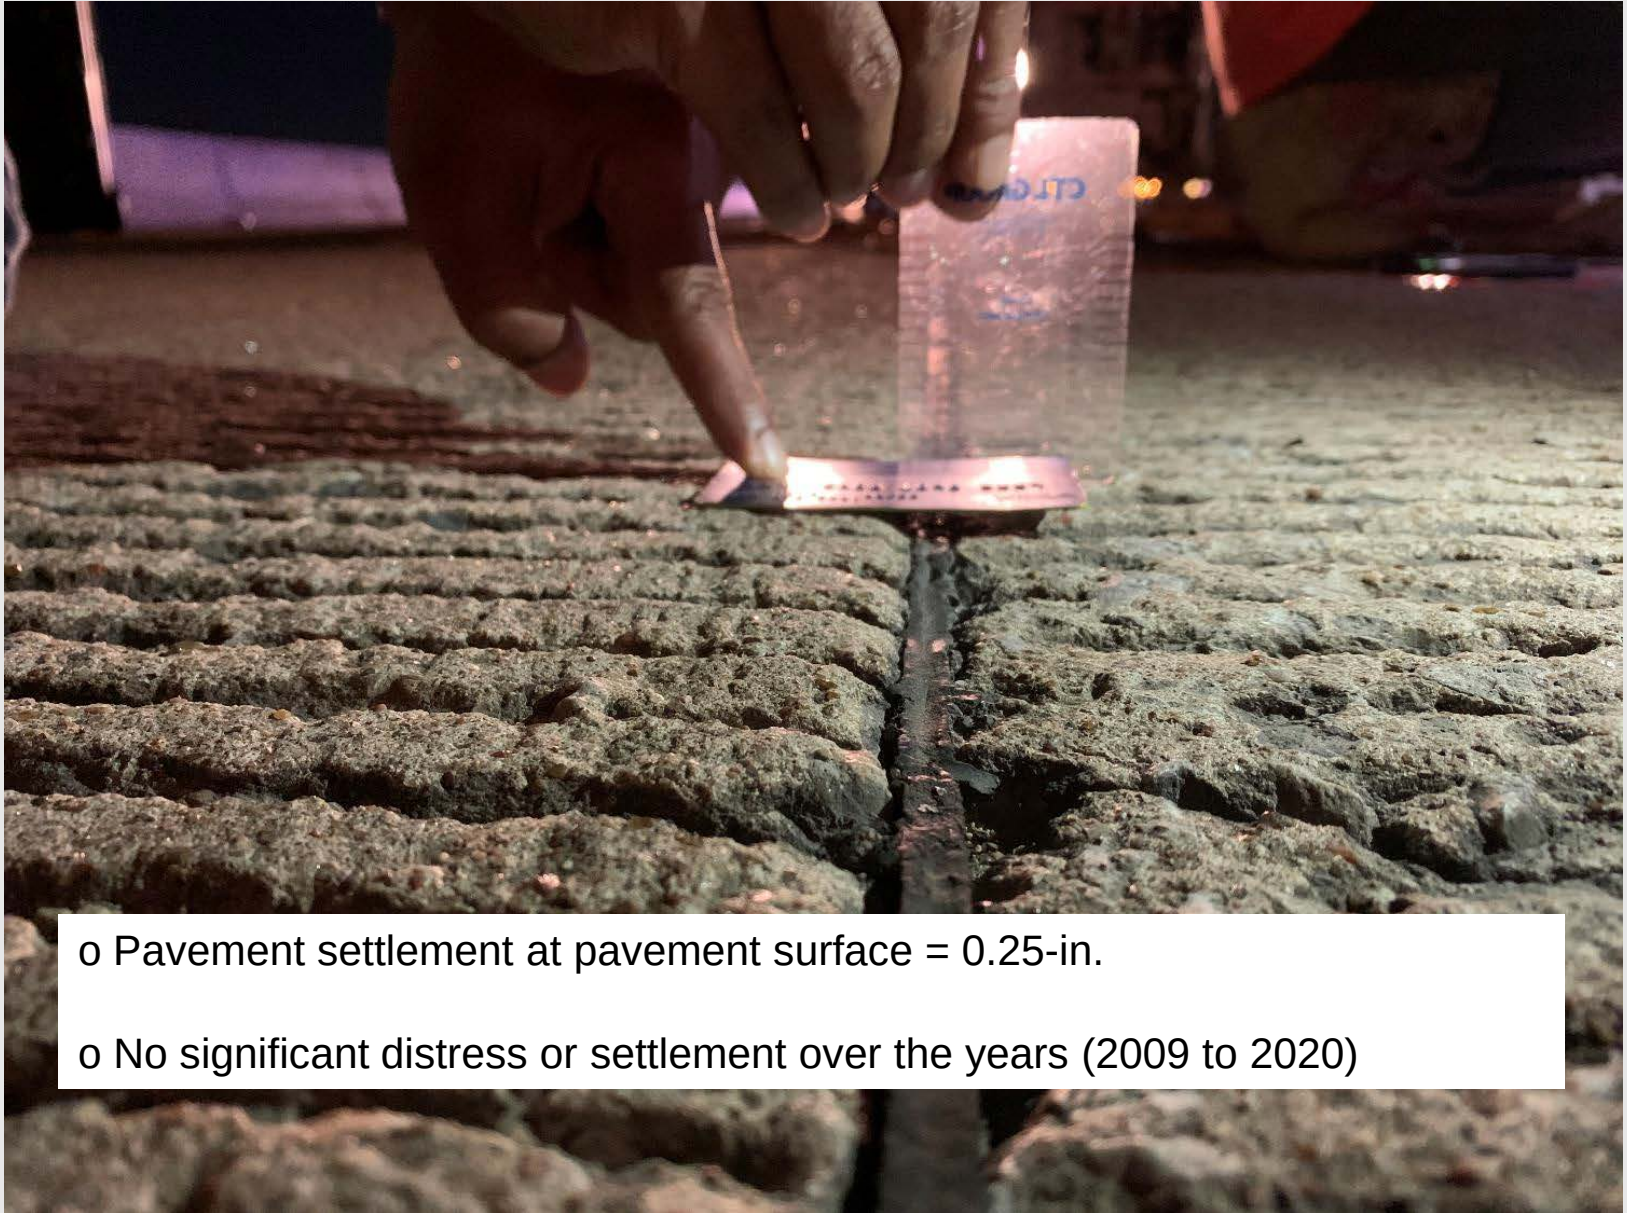
## □ Typical Distress – Localized CRCP Settlement at L2

o Pavement settlement at pavement surface = 0.25-in.

o No significant distress or settlement over the years (2009 to 2020)

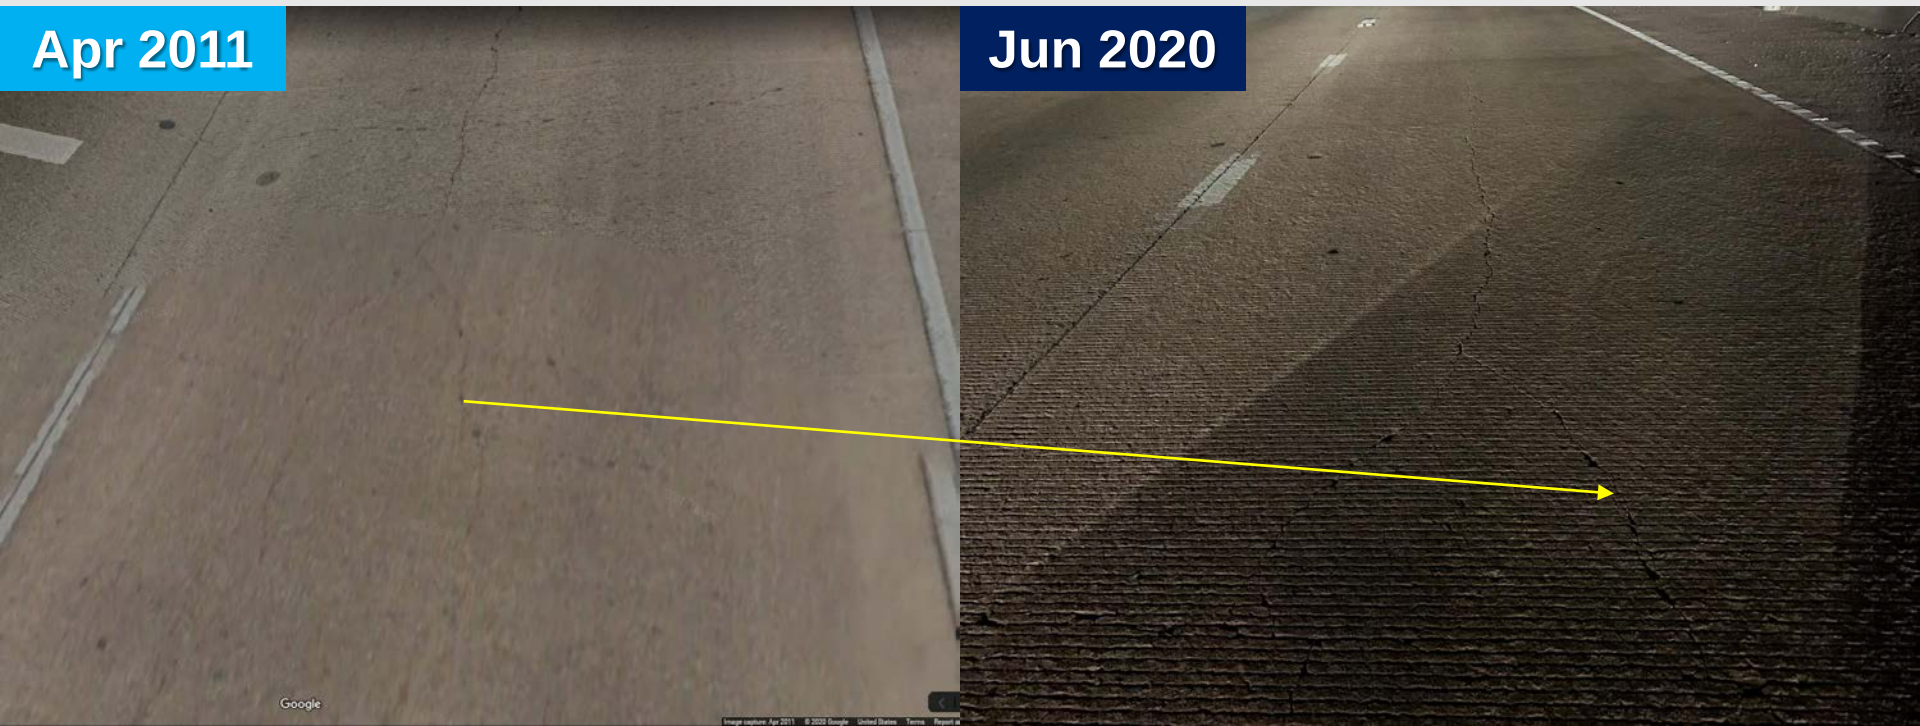
## □ Typical Distress: Localized Longitudinal Crack at L1 & L3

- No significant crack progress from April 2011 to June 2020

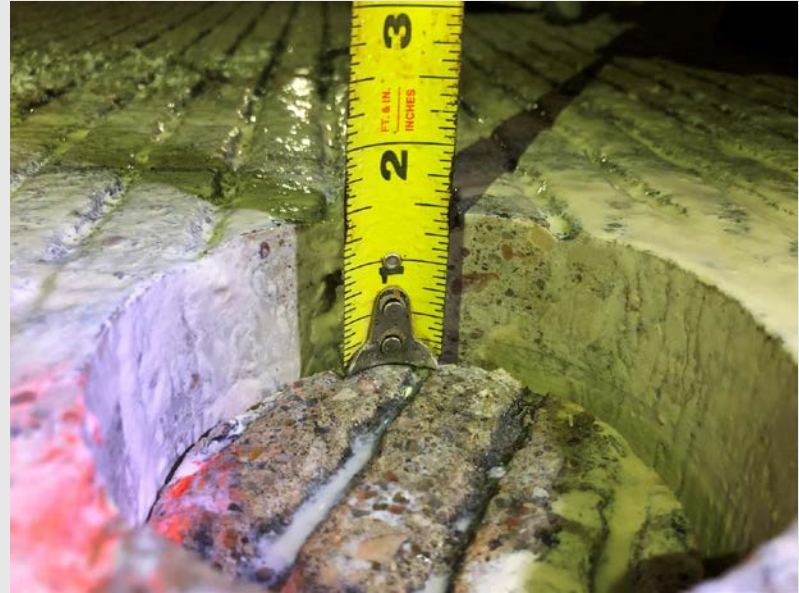
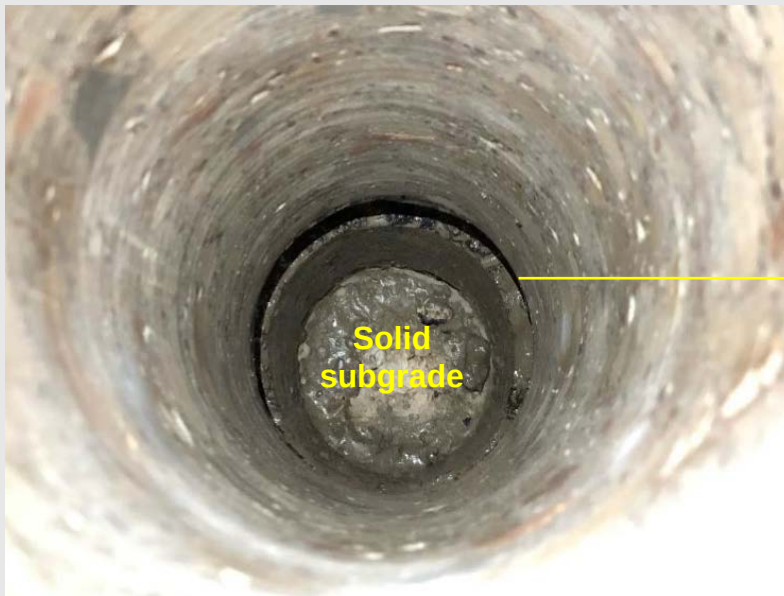
## □ Void Thickness Measurements

- Large deflections were measured in both wheel paths of L2
- Deflection in L1-LWP was slightly higher than statewide average (2.0-mil) due to settlement in L2, resulting in longitudinal crack.

- **Option #1) Continue to monitor until a repair strategy can be scheduled**
  - Pros: No immediate cost
  - Cons: The void and settlement are not repaired
- **Option #2) Preventive maintenance concept – Pressure grouting (SS 3051)**
  - Repair limit:
    - Length = 450-ft. (200-ft to 650-ft from the BAS)
  - Pros: Moderate cost (\$\$) & void is filled
  - Cons: Void may not be filled 100%
- **Option #3) Full-depth repair**
  - Pros: Void and settlement are repaired
  - Cons: Increased cost (\$\$\$), involves lanes 1-3, traffic control impacts traveling public (close up to 3 lanes w/ positive barrier or full freeway closure) and construction challenges

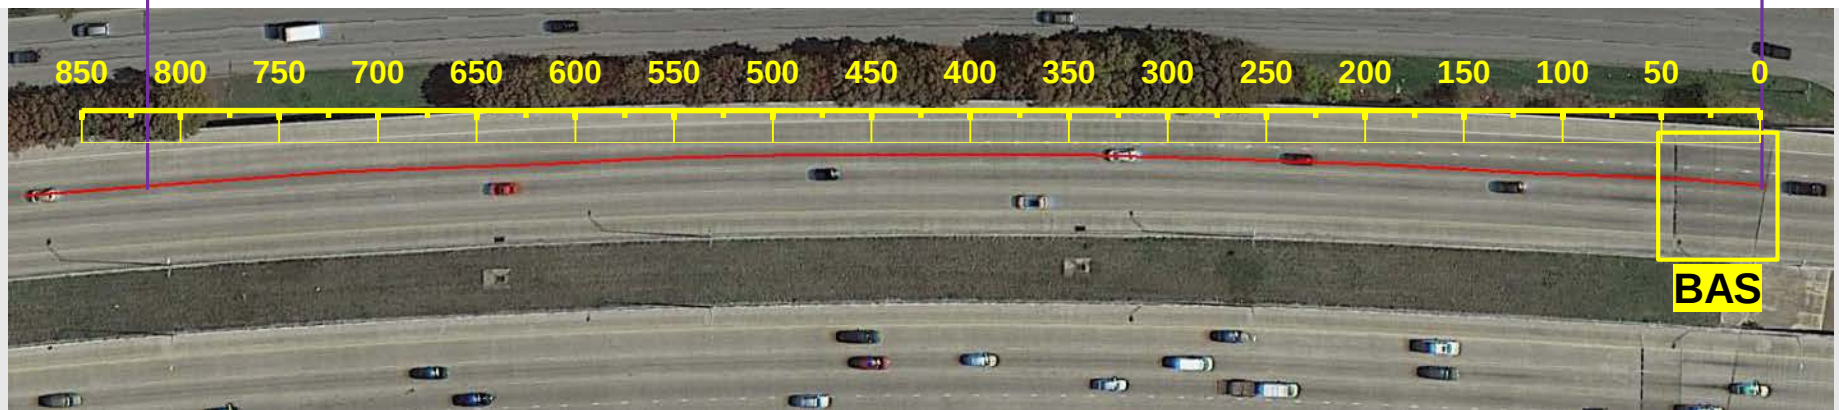
## Estimated Void Thickness Profile (L2 – RWP)

- Largest deflection profile is used to estimate the void profile.

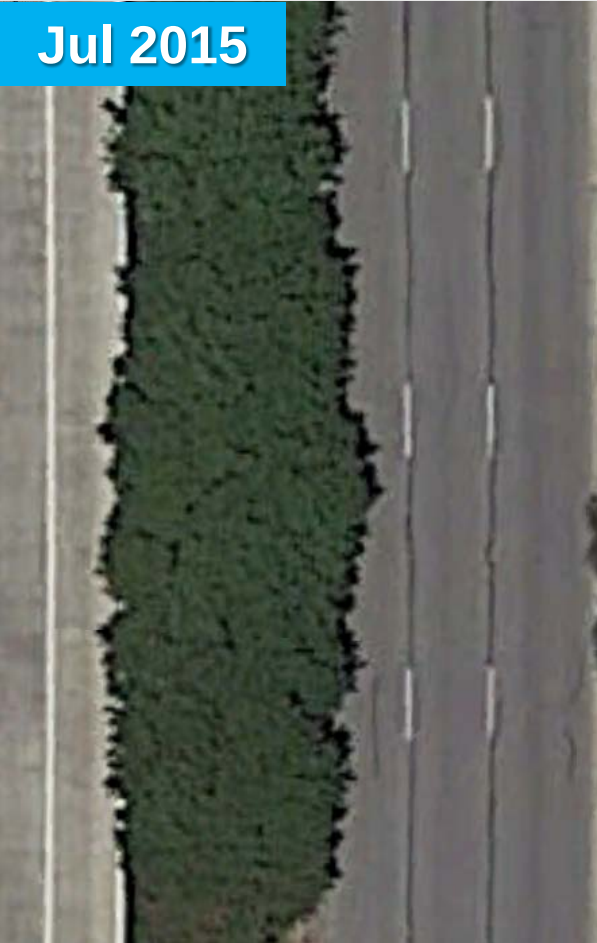
Jul 2015

PI = 34

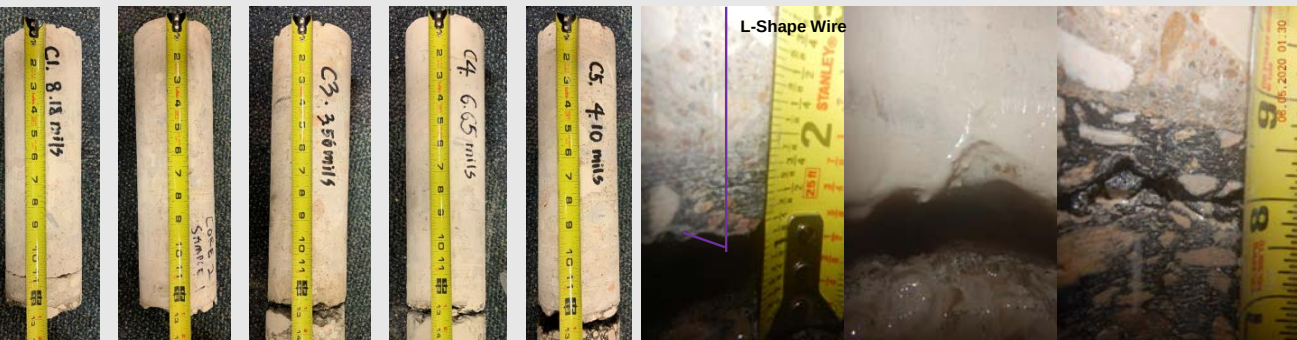
## Inspection Considerations

- Develop a detailed plan to avoid grouting material loss
- Identify drilling depth and condition for each hole
- A minimum of 13-in. depth drilling/no more than 15.0-in. drilling
- MIRA system can be used to identify drilling depth.

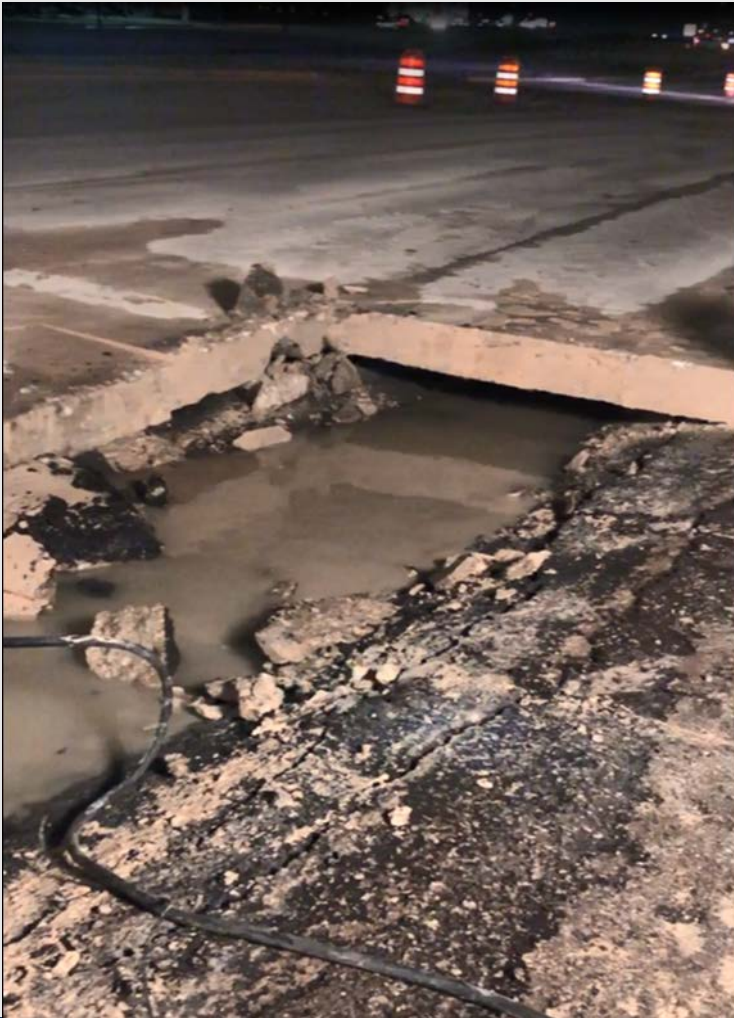
- A distressed section was previously repaired (full depth)

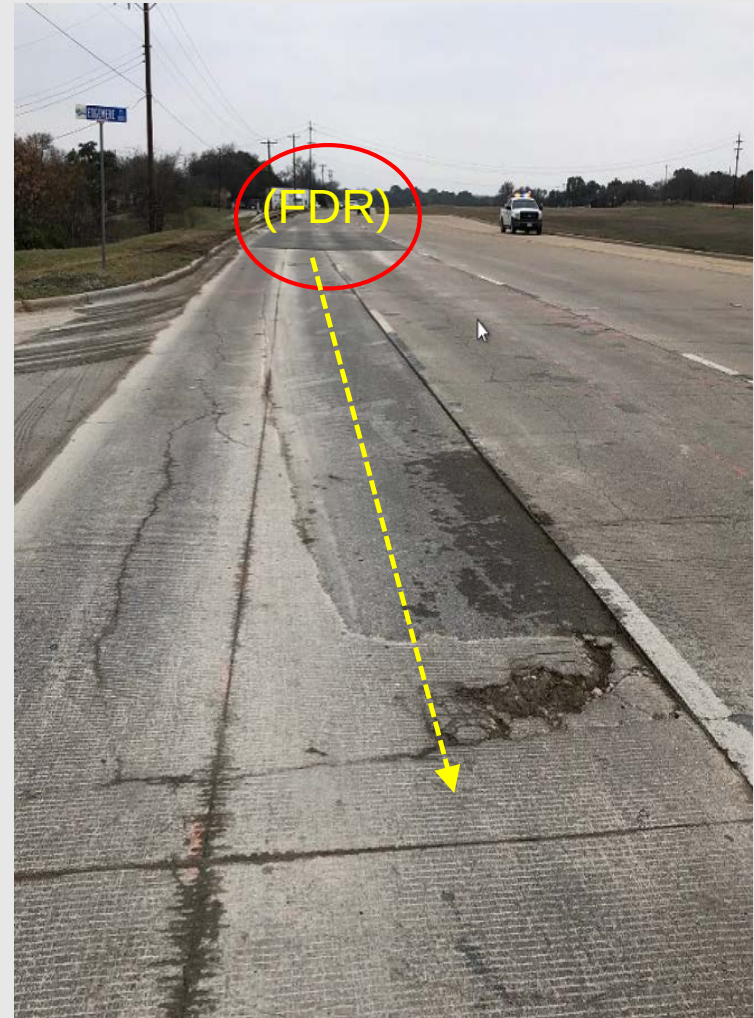
- The problem continues beyond the repaired section

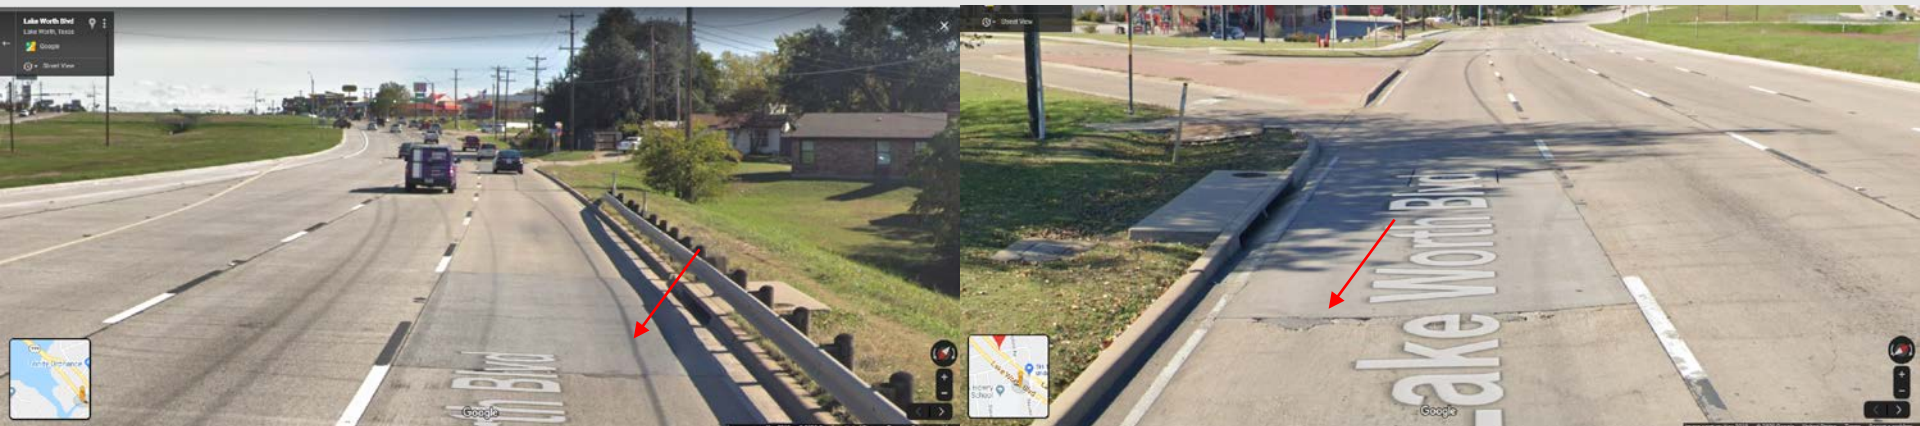
## □ Cause of the Secondary Distress at FDR Joint

- Longitudinal cracks and pavement settlement
- Secondary distress at FDR joints
  - Free movement at FDR joint (not allowed in CRCP FDR)
    - Cleaning/not enough epoxy injection/not enough epoxy curing time & pull-out strength during epoxy application
    - Continuity should be provided.

- **Distress at FDR Joints**
  - CRCP **does not allow independent movement at FDR joints**. FDR joints should be fully connected like a single slab.
  - Secondary distresses at FDR joint appear to be related with free movement at FDR joints; possibly due to inadequate epoxy application during construction.

- Loose base material should be completely removed.
- Clean drilled holes with compressed air.
- Entire hole has to be filled with epoxy and confirmed by the inspector.
- The number of epoxy cartridges used in FDR should be monitored and verified by the inspector.

Place tie bars as shown on the plans. Drill holes into the existing concrete at least 10 in. deep unless otherwise directed. Use a drill bit with a diameter that is 1/8 in. greater than that of tie bars. Clean the holes with a wire brush and compressed air to remove all the dust and moisture. Follow the epoxy manufacturer's instructions to apply the epoxy. Insert the tip of the epoxy cartridge or the tip of the machine applicator to the end of the tie bar hole, and inject Type III, Class C epoxy to fill the entire hole. Insert tie bars.

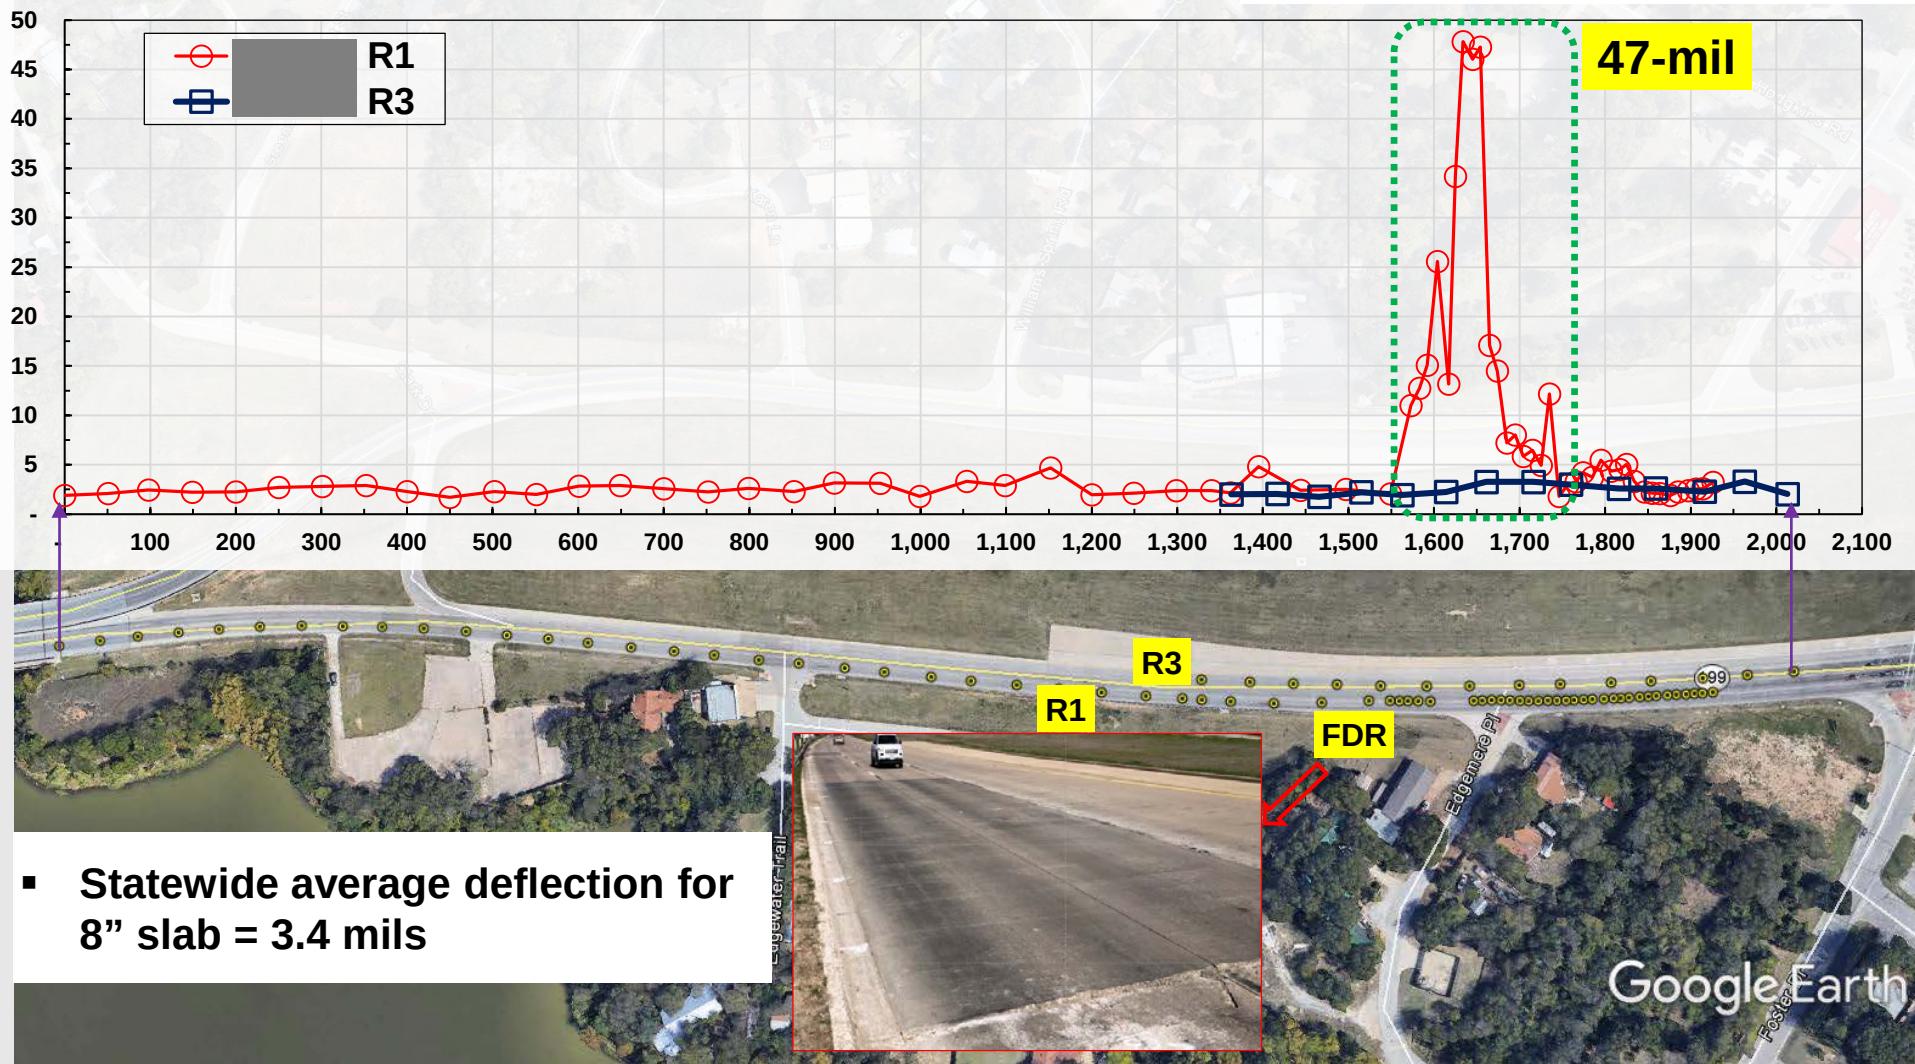
## 5.3 FWD Testing – Deflection Profile

Problem Area at R1 & R2  
(Void beneath CRCP slab due to subgrade settlement → water channel)

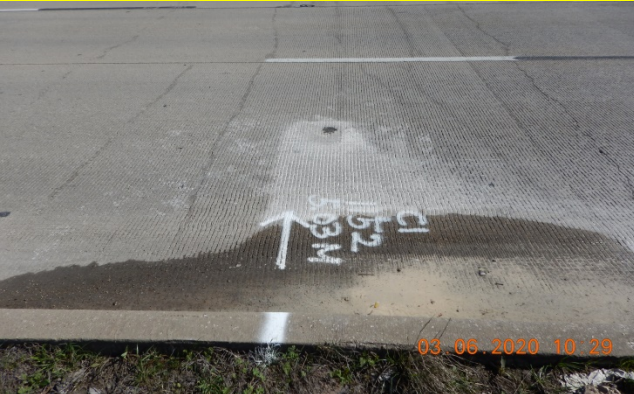
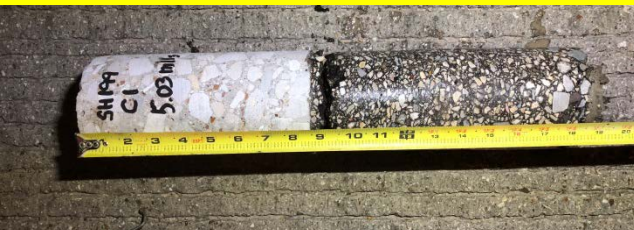
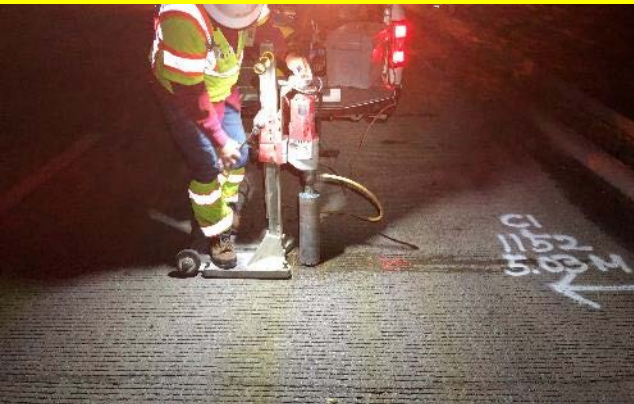
**C1, 4.7-mil**

**8.5-in. CRCP & 10-in. HMA**

**No Void (soft soil)**

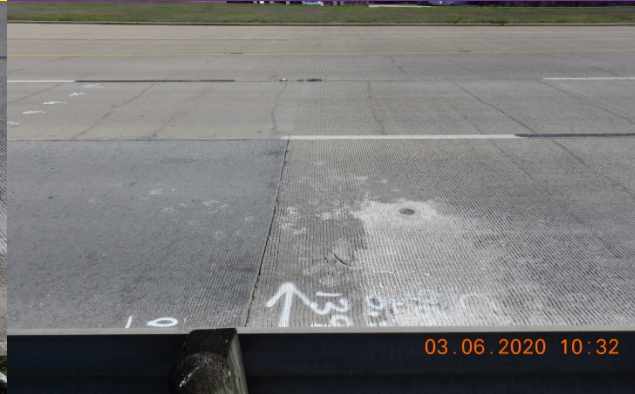
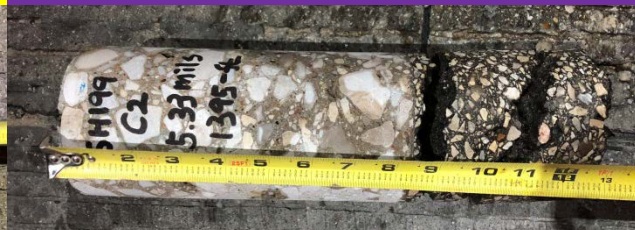
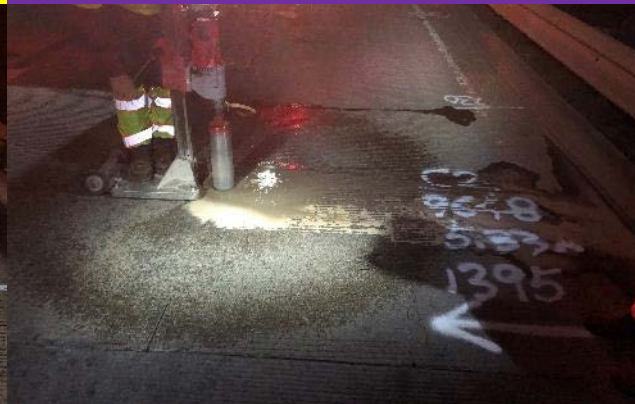
**C2, 4.8-mil**

**8.3-in. CRCP & 4-in. HMA**

**No Void (moderate soil)**

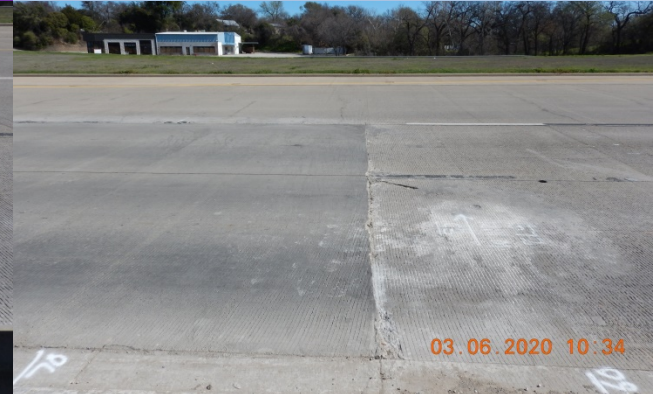
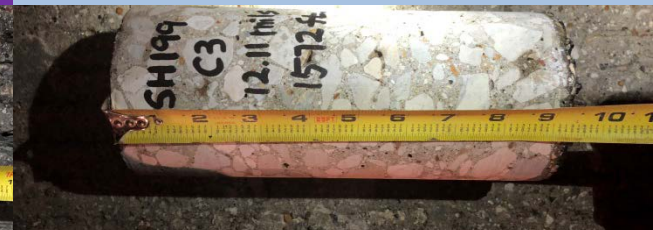
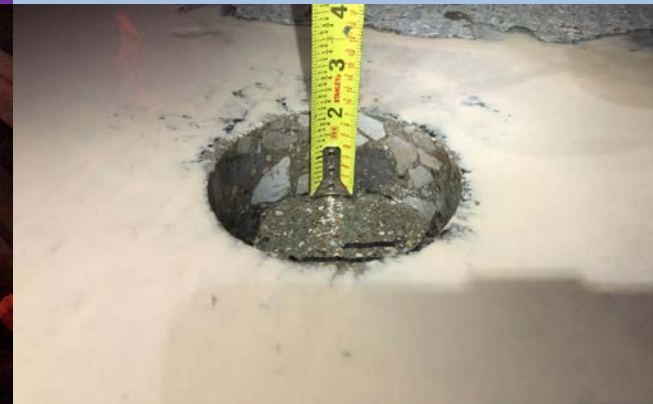
**C3, 11.0-mil**

**9.0-in. CRCP**

**2.0-in. Void**

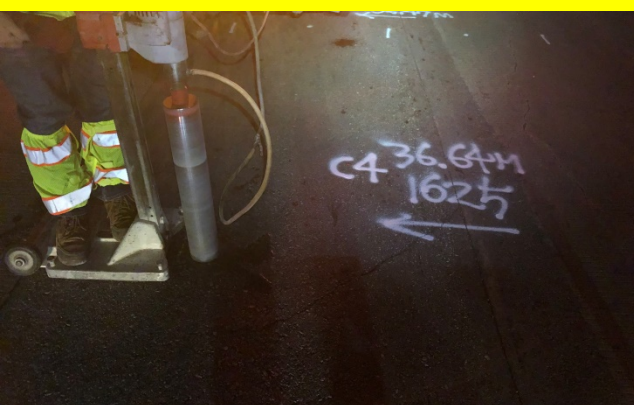
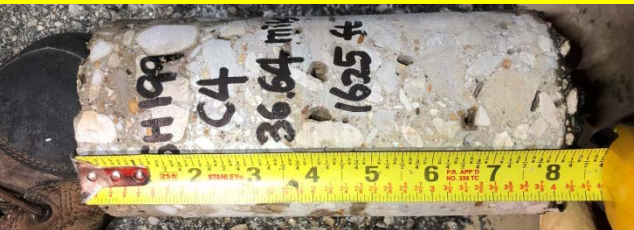
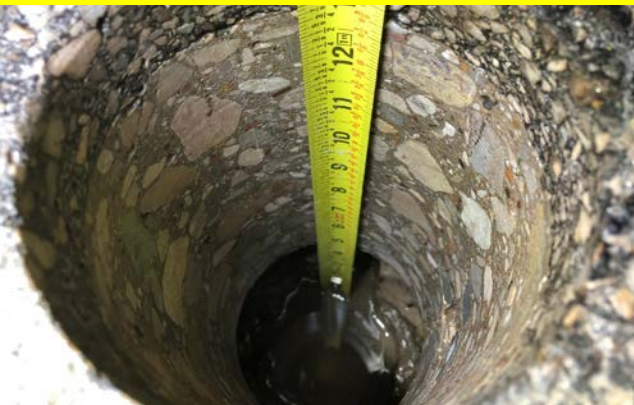
**C4, 34.2-mil**

**8.0-in. CRCP**

**4.5-in. Void**

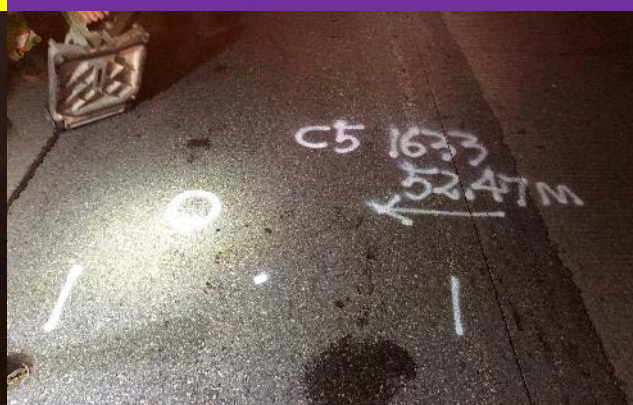
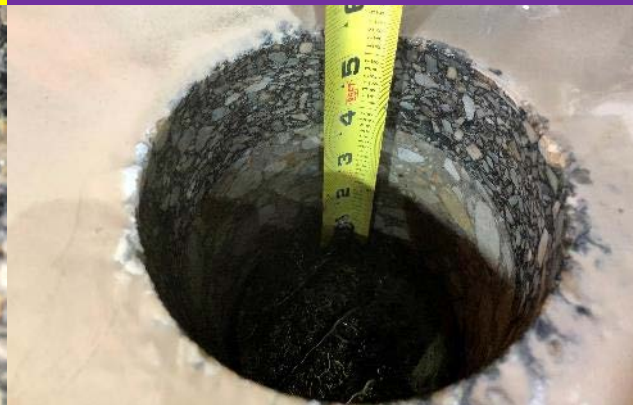
**C5, 47.8-mil**

**8.0-in. CRCP**

**Core sample was not collected – no photo.**

**5.3-in. Void**

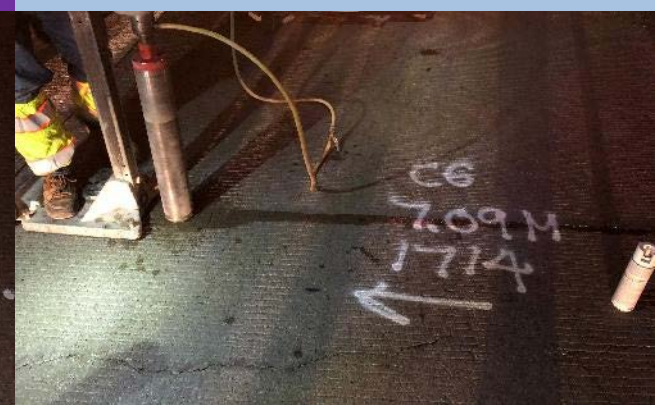
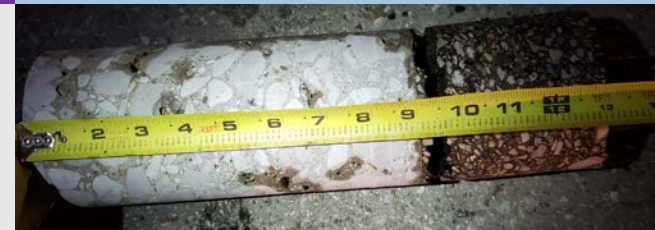
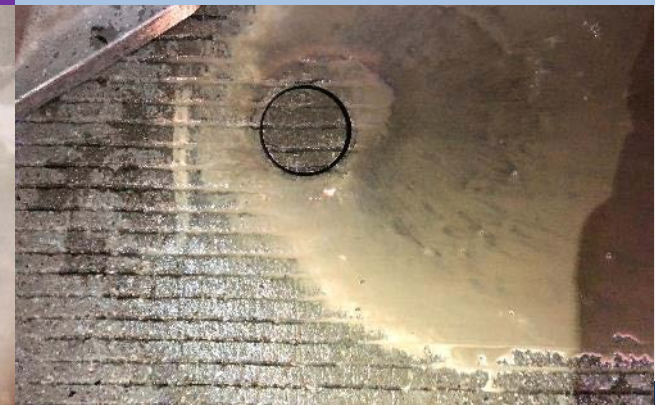
**C6, 6.5-mil**

**9.0-in. CRCP + 4.0-in. HMA + 8.0-in. CTS**

**No Void (soft CTS & soil)**

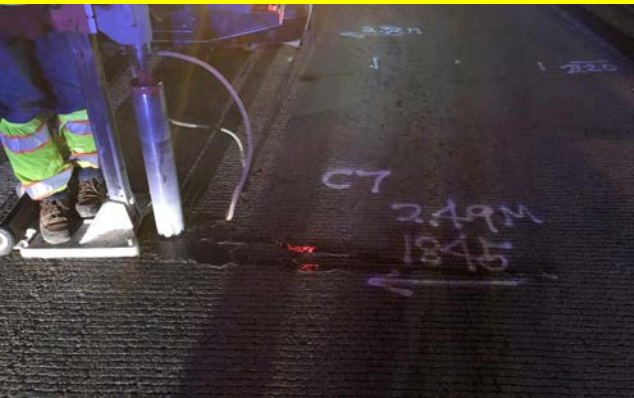
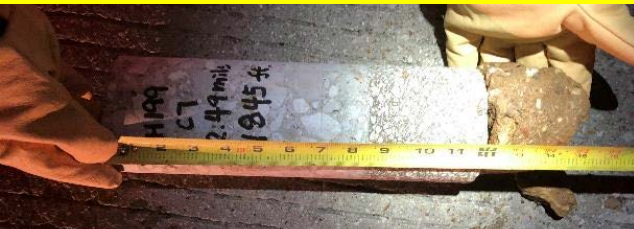
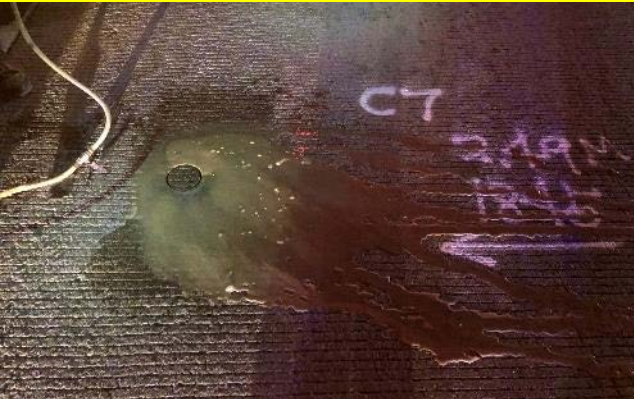
### C7, 2.3-mil

- Solid CTS (strong) – DCP testing was not able to be done in CTS layer so **testing was conducted after coring the 12-in. CTS layer**
- Very strong natural soil

8.0-in. CRCP + 3.8-in. HMA + 12.0-in. CTS

No Void (Strong CTS & Soil)
