# CRCP Evaluation and Forensic Studies

Roberto Treviño Flores, P.E.

## 4. Case Study #1 – Austin District

## 5. Case Study #2 – Ft. Worth District

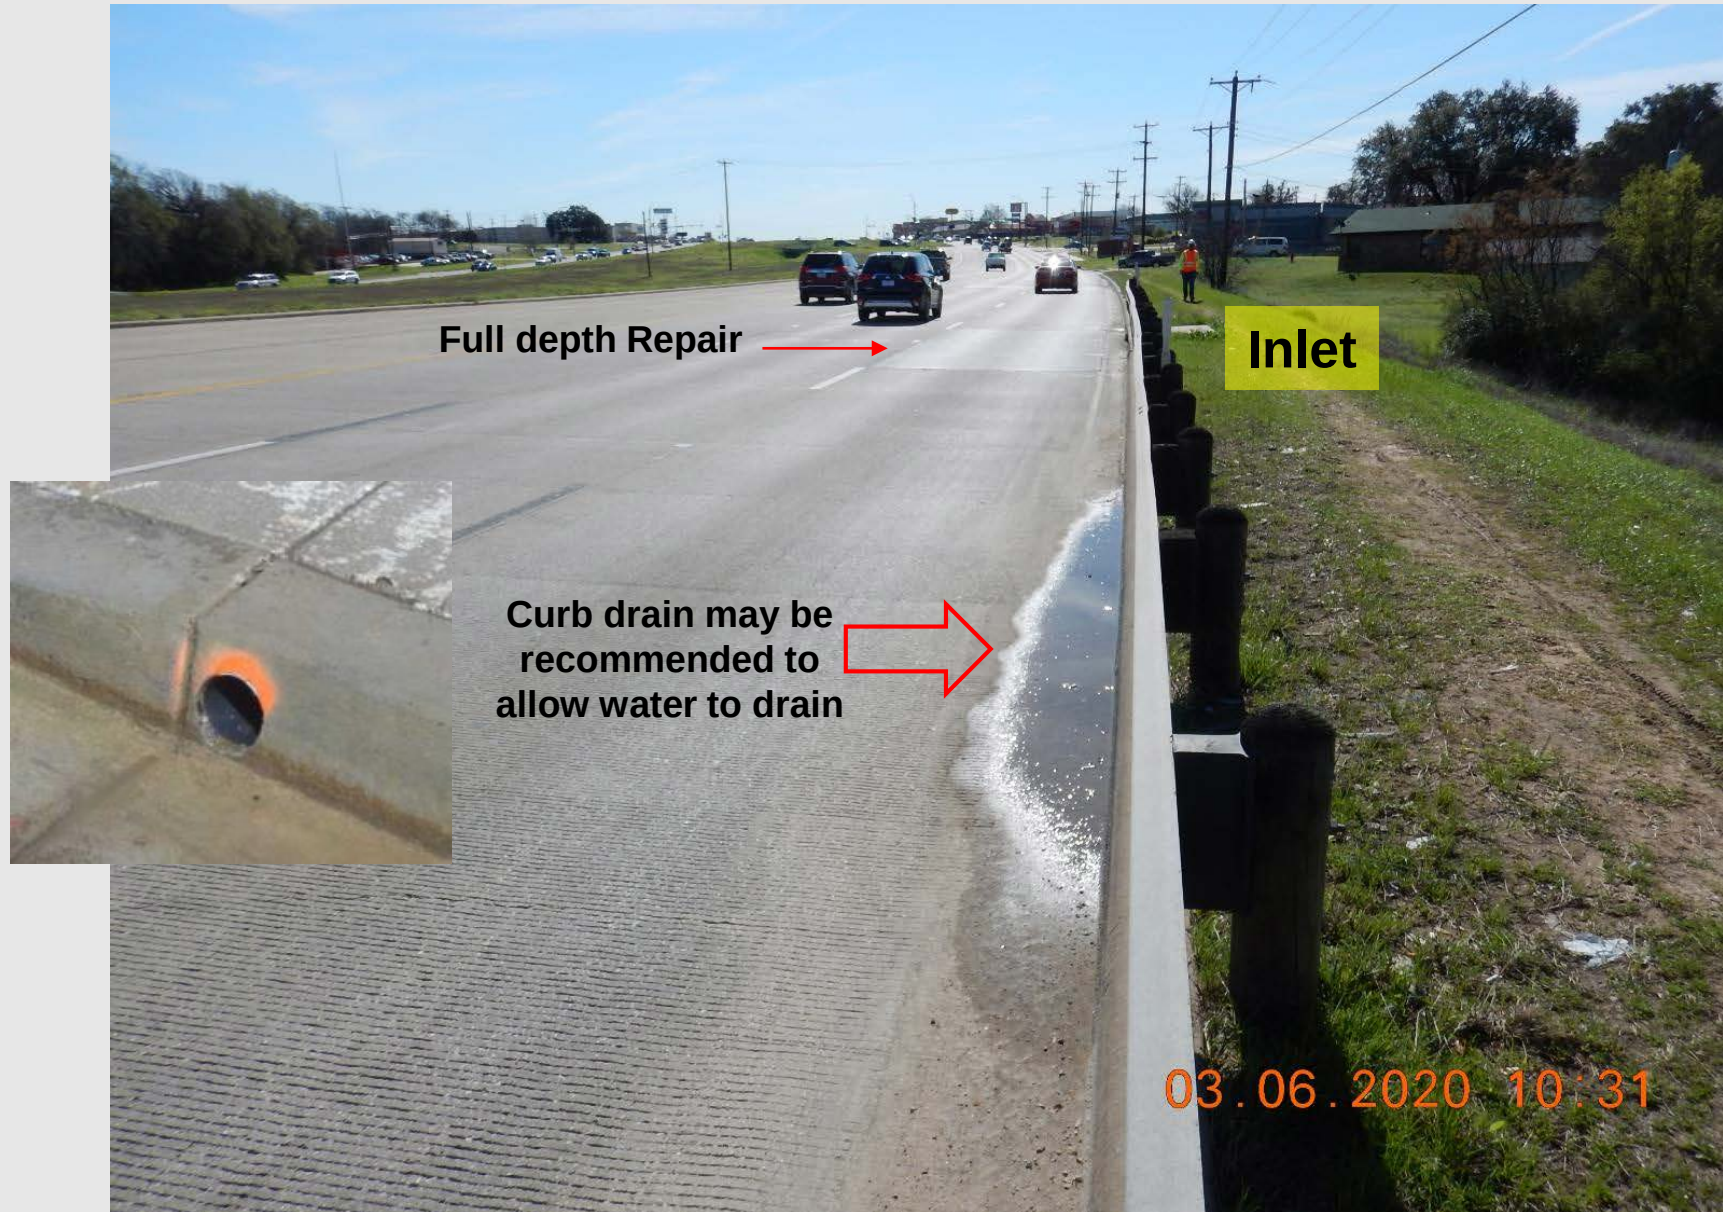
## □ Half-Moon Shape Crack & FDR in Fill Section (LiDAR Image)

- **Cause of Pavement Settlement and Longitudinal Crack**
  - Subgrade settlement and previous FDR occurred in the area with natural soil with high organic matter/high PI.
  - The fill section was placed over the high organic/high PI zone.
  - **Inadequate compaction around pipe and culvert** resulting in immediate settlement

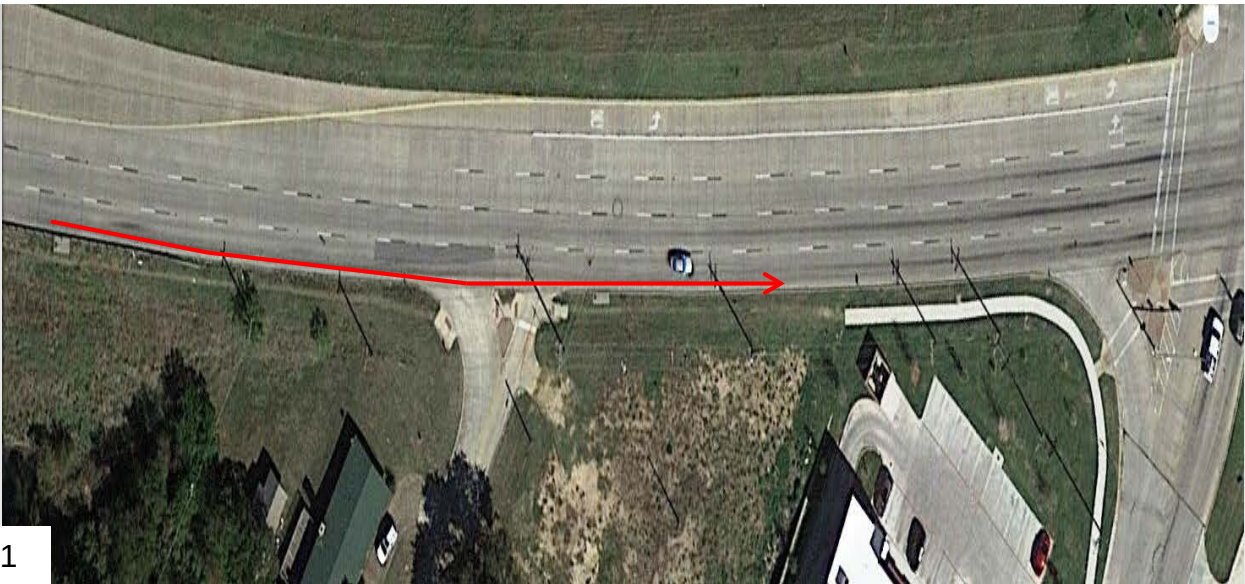
The GC-GPR profile scan is placed on the plans sheet to show the approximate depth.

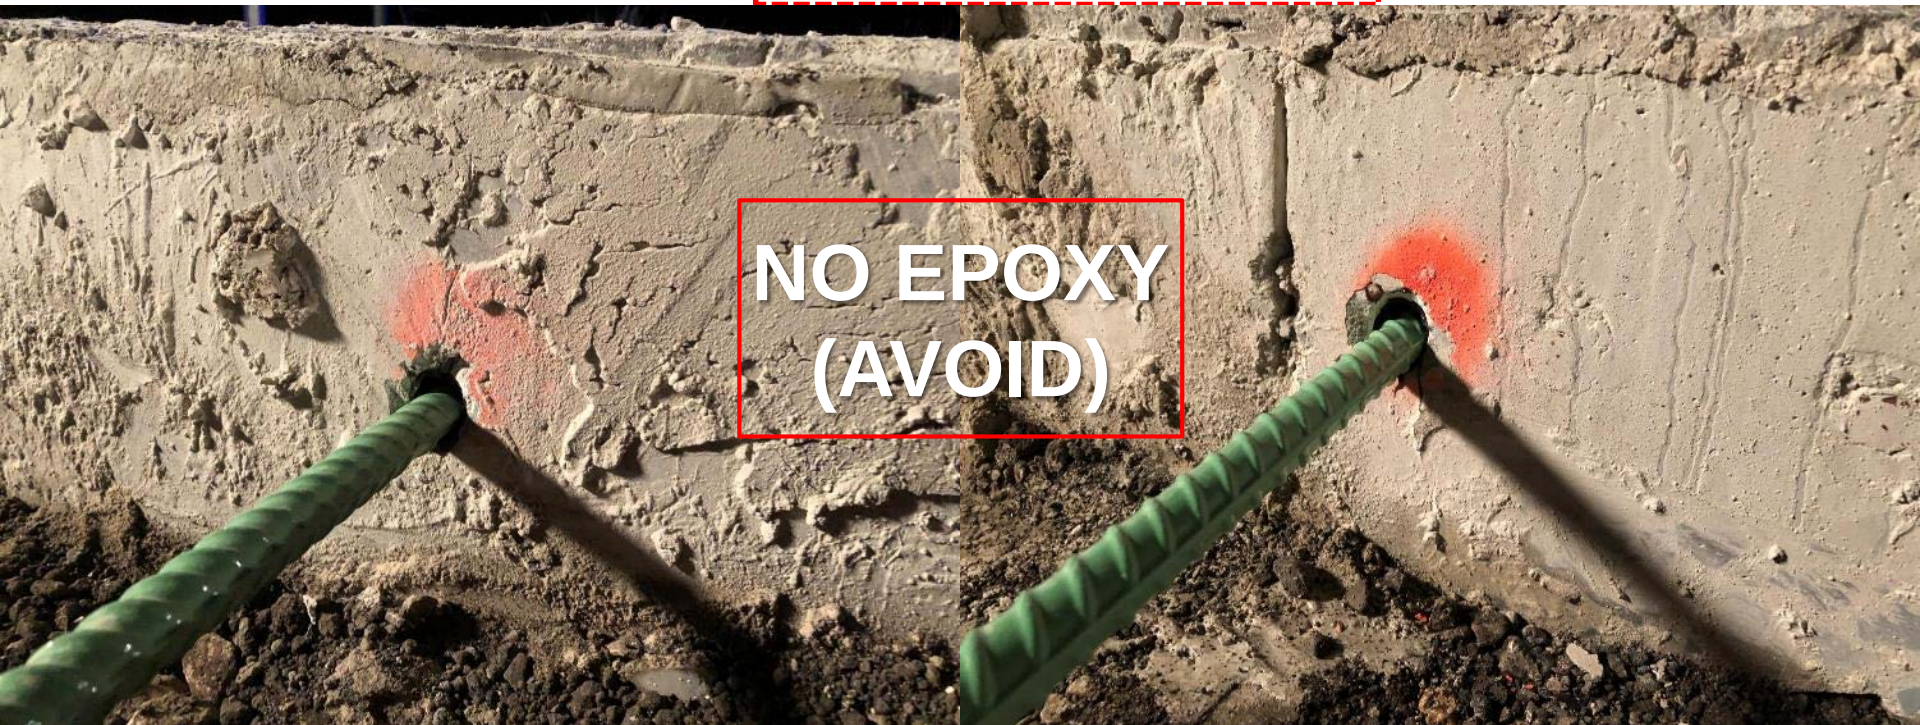
## ○ Fill the Entire Hole with Class C Epoxy (Epoxy Injection)

Place tie bars as shown on the plans. Drill holes into the existing concrete at least 10 in. deep unless otherwise directed. Use a drill bit with a diameter that is 1/8 in. greater than that of tie bars. Clean the holes with a wire brush and compressed air to remove all the dust and moisture. Follow the epoxy manufacturer's instructions to apply the epoxy. Insert the tip of the epoxy cartridge or the tip of the machine applicator to the end of the tie bar hole, and inject Type III, Class C epoxy to fill the entire hole. Insert tie bars.

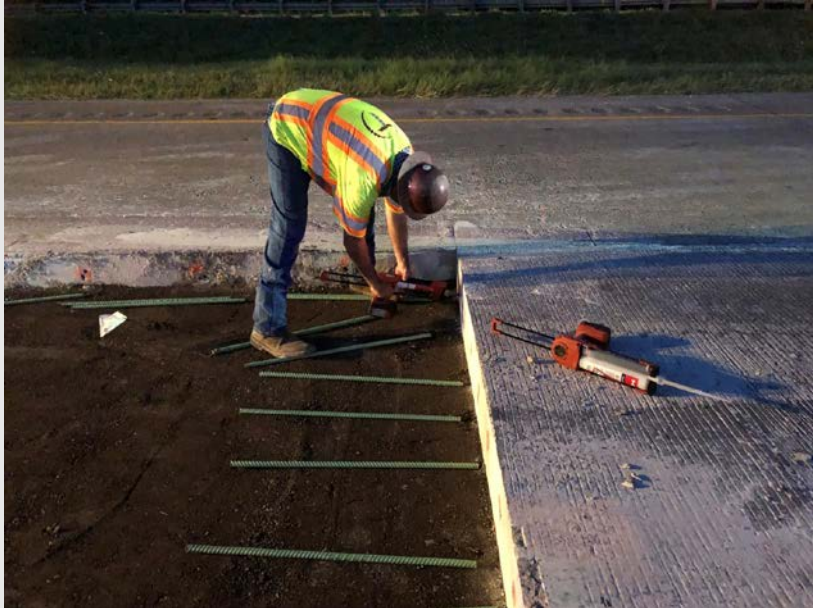
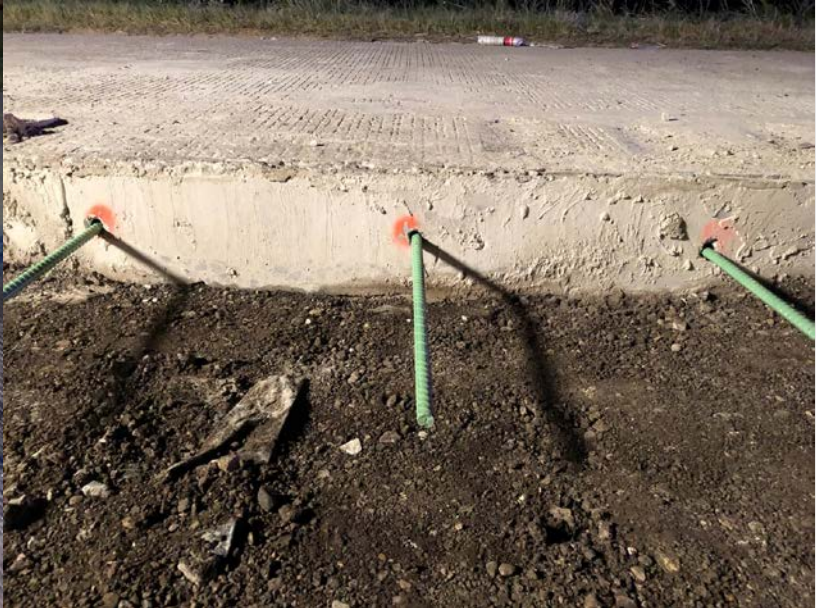
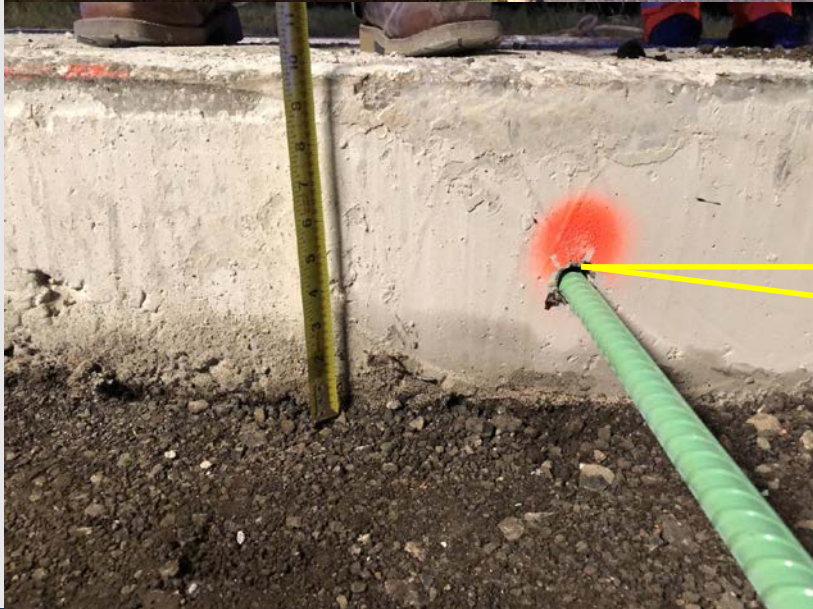
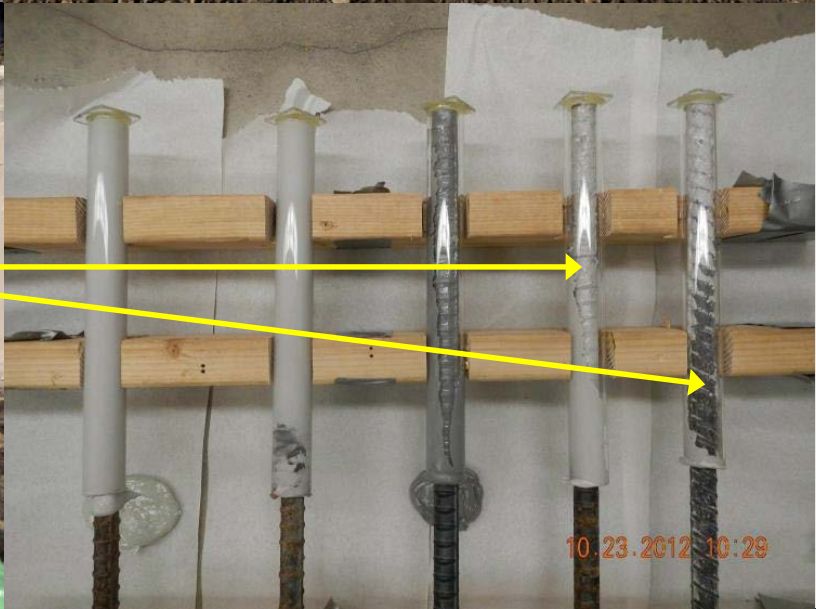
## ○ Example of Not Enough Epoxy

- **Distress at FDR Joints**
  - CRCP **does not allow independent movement at FDR joints**. FDR joints should be fully connected like a single slab.
  - Secondary distresses at FDR joint appear to be related with free movement at FDR joints; possibly due to inadequate epoxy application during construction.

- Loose base material should be completely removed.
- Clean drilled holes with compressed air.
- Entire hole has to be filled with epoxy and confirmed by the inspector.
- The number of epoxy cartridges used in FDR should be monitored and verified by the inspector.
